# THE SOCIAL AND ENVIRONMENTAL COMPLIANCE ASSESSMENT FOR TILENGA OIL PROJECT

A CIVIL SOCIETY FIELD MONITORING REPORT

**CSCO Research Paper Series No.12, 2023**

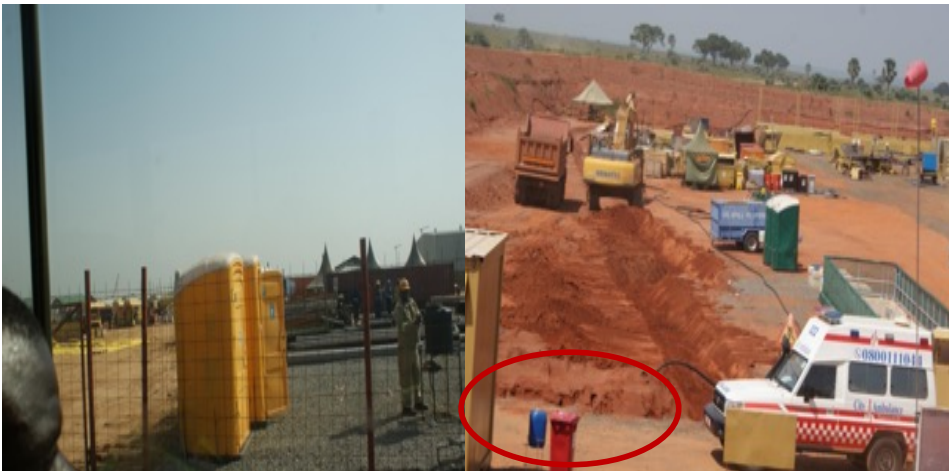
**Figure 4: Pictures showing sanitary facilities such as water points for hand washing and movable toilets on sites.**

There were sanitary facilities including toilets, eco-loos, and hand washing facilities at all the active construction sites visited. There were also a number of signage materials encouraging the workers and all the Persons on Board (POBs) to wash their hands.

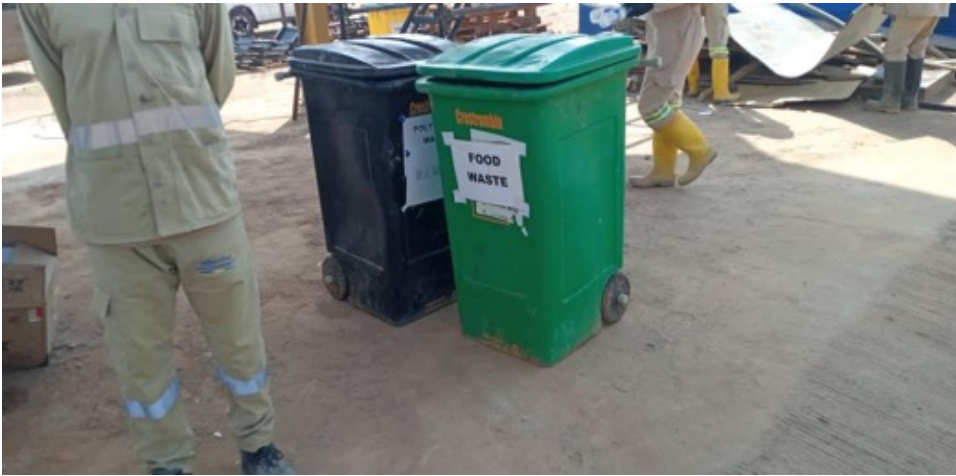
**Figure 5: Color waste bins for separation of different waste types at the industrial area in Buliisa district.**

There were provisions for waste separation at all the active construction sites within the Tilenga project area. This good practice is commendable and is in line with the IFC General EHS Guidelines for handling waste at construction Facilities (2007), which provide that non-hazardous waste, such as paper, cardboard, glass, aluminum, and plastic, should be collected separately and recycled. Also, the biodegradable solid waste is being composted for the generation of compost manure.

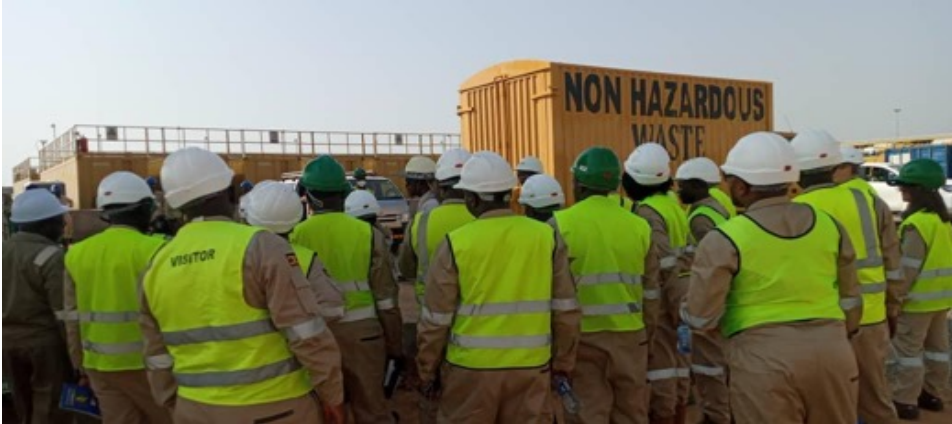
The workers at all development sites visited had basic PPE (safety shoes, gumboots, reflective vests, helmets and nasal masks) for protection from hazards such as dust, aerosols, and bites from insects and reptiles. This practice complies with Section 19(1) of the Uganda National Occupational Health and Safety Act (2006), which mandates an employer to provide adequate and suitable protective clothing and equipment to workers. Furthermore, it was observed that TEPU has reserved PPEs for visitors to ensure everyone's safety while on the sites.

**Figure 6: CSCO field team wearing personal protective equipment (PPE) at the industrial area construction site.**

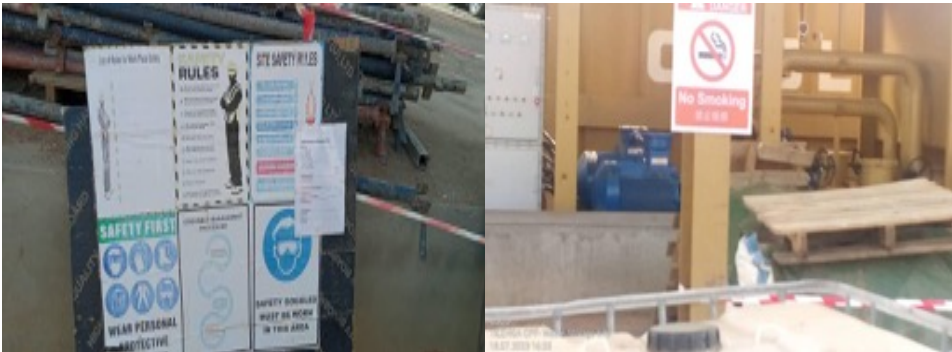
**Figure 7: Safety signage at the industrial construction site in Kasinyi village, Buliisa district.**

Construction sites in the Tilenga project area were all well labelled with safety marks such as “No smoking” signs, “Slow Down Speed Limits,” and the “Wear PPE” signs” among others. Additionally, names of Persons on Board (POBs) were displayed at the entrance of sites, except for the JBRI-5 Well-Pad Construction site, where the names of POBs were located in a restricted area for visitors.

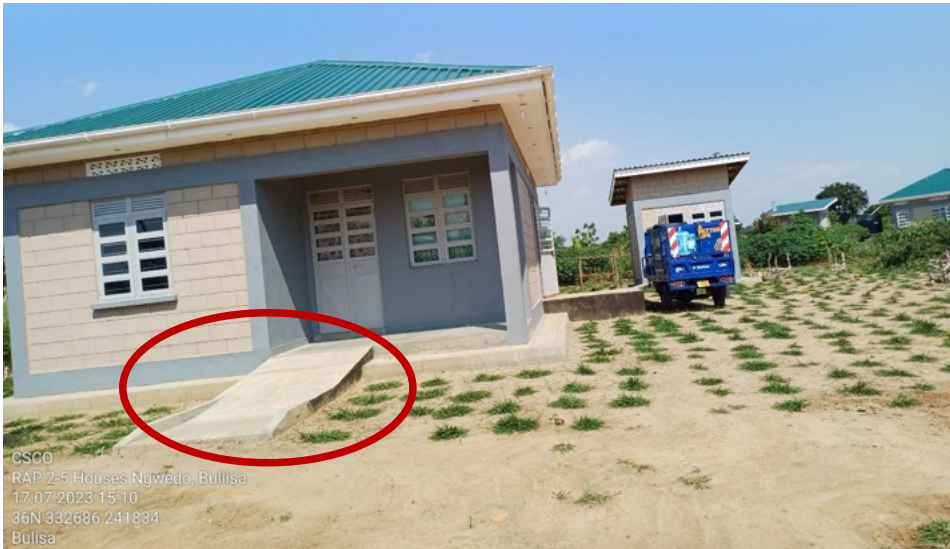
**Figure 8: Ramp (in the encirclement) at one of the newly constructed RAP 2-5 Resettlement Houses in Ngwedo, Buliisa District.**

of the newly constructed RAP 2-5 resettlement houses in Ngwedo. This practice is commendable, and is in compliance with Section 7.1.5 of the National Physical Planning Standards and Guidelines (2011), which stipulates that building designs must consider the needs of the disabled, particularly those with mobility handicap.

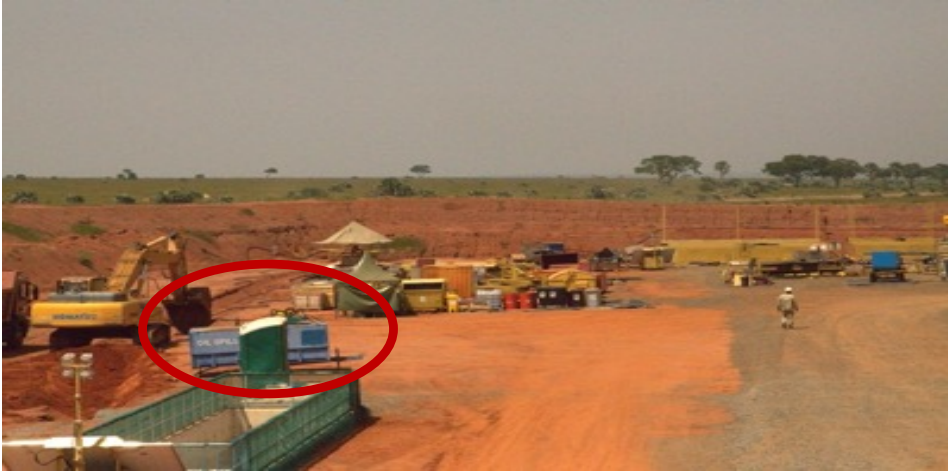
**Figure 9: Emergency Oil Spill Response Kit (in the encirclement) at JBRI-5 Well -Pad construction site in Murchison Falls National Park.**

The sites visited, such as the JBRI-5 Well-Pad construction area and the Industrial Area, had several emergency response facilities and equipment. These included oil spill contingency kits, fire-extinguishers, first aid boxes, and emergency assembly points placed in visible and accessible areas. This practice aligns with the IFC World Bank (2007) General Guidelines, which mandate facility operators to establish public emergency response programs and ensure that the spill-handling equipment and tools for major accidents are readily available in visible and accessible areas of the facility.

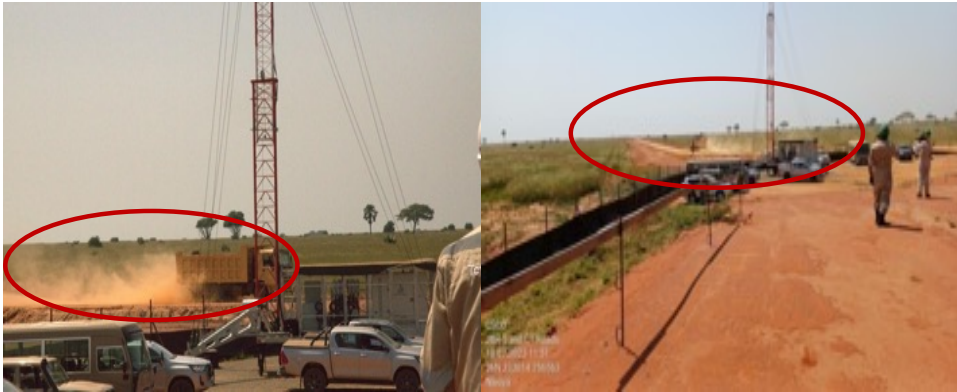
**Figure 11: Dust emission and uncovered contractor's truck along C1 road near JBRI-5 well-pad construction area.**

However, the current monitoring conducted in July 2023 observed that this practice seems to have been abandoned. No water bowsers were observed during the visit, resulting in evident dust emissions. The trucks carrying materials from construction sites were uncovered, especially along the section of C1 road near JBRI-5 well pad construction area.

If not adequately addressed, dust emissions may have negative impacts on the health wildlife in Murchison Falls National Park (MFNP). Additionally, for human community-based projects such as the industrial area construction site in Buliisa, uncontrolled dust emissions may cause health problems to the people in the nearby communities. This would be contrary to Article 39 of the Constitution of the Republic of Uganda, 1995 (as amended) which guarantees the right to a clean and healthy environment for every Ugandan.

No	Issues	Responses
4.	<p><b>Dust emissions and control of materials spillages from transportation trucks</b></p> <p>During the previous monitoring, it was noted that the TEPU Contractors controlled dust emissions through the use of water bowsers, and that spillage of construction materials from the transportation trucks were controlled by covering trucks with tarpaulins. However, the current monitoring (July 2023) noted that the practice seems to have been abandoned as no water bowsers were observed during the visit. Dust emissions were evident, and uncovered trucks carrying materials, muds and cuttings from construction sites were observed; especially along the section of C1 road near JBRI-5 well pad construction area. If not adequately addressed, dust emissions may negatively impact wildlife in Murchison Falls National Park (MFNP), as well as lead to a loss in the aesthetic beauty of the Park. For the human community-based projects such as the industrial area construction site in Buliisa, uncontrolled dust emissions may cause health problems to nearby communities contrary to Article 39 of the Constitution of the Republic of Uganda, 1995 (As Amended) which calls for a right to a clean and healthy environment for every Ugandan.</p>	<p>Dust suppression by contractors is an on-going activity undertaken daily. Environment Health and Safety (EHS) officers continuously monitor the need for the suppression and accordingly deploy the trucks in those locations. Truck drivers are continuously reminded of the need to cover the trucks carrying materials and maintain speed limits during the daily toolbox meeting. The impact of project activities on the national park ecosystem is monitored routinely through various biodiversity studies on-going.</p> <p>Findings are widely shared with contractors to implement mitigation measures for any outliers.</p> <p>On the day of the inspection, there must have been some laxity in suppression on the side of the contractor – SINOPEC but TEPU will continue to emphasize and implement dust suppression activities (Below Picture). Runoff collection and its utilization for this dust suppression is also utilized where practical. Dust suppression is also communicated in project toolbox talks</p>

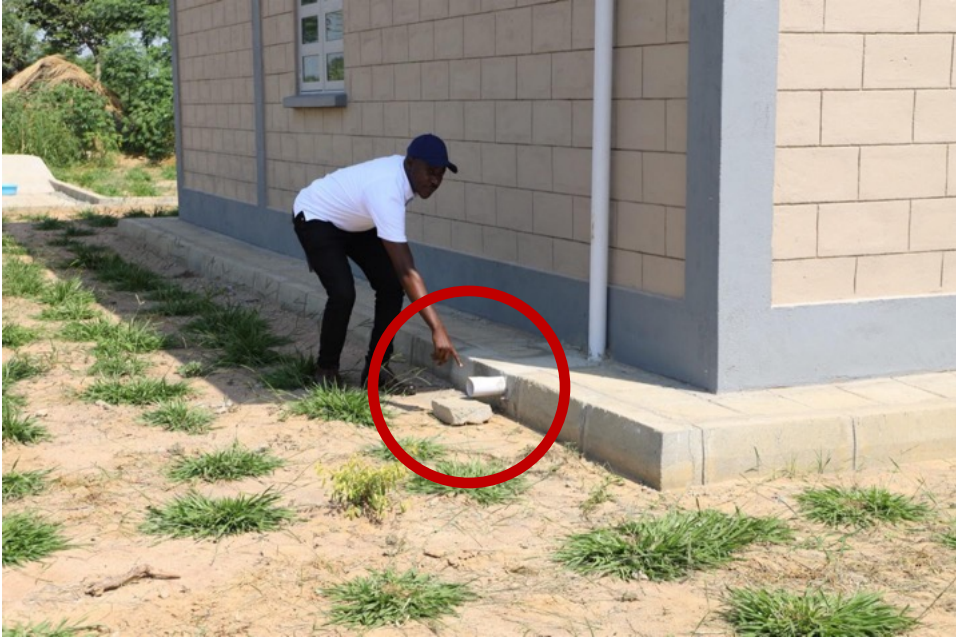
**Figure 12: Gutters from the roof at one of the newly constructed Tilenga RAP2-5 Resettlement houses (in the encirclement) not connected to any outfall drainage system for safe disposal of storm water.**

In 2022, the civil society monitoring team highlighted deficiencies in the designs for storm water disposal at resettlement houses. During the current visit in July 2023, it was found that while grass had been planted in the compounds of the PAPs houses in response to TEPU's commitment following CSCO's previous observation, the issue of gutters not properly being connected to any outfall drainage system still persists.

It is important to note that the failure to connect gutters to an outfall drainage system creates dampness in buildings and accelerates weakening through capillary attraction and the seepage of uncontrolled storm water. Leaving building gutters open is contrary to regulation 3.3.6.1 of the National Building Control Regulations.

No	Issues	Responses
5.	<p><b>Designs for storm water disposal at resettlement houses</b></p> <p>The previous CSCO monitoring report (2022) noted lapses in the designs for storm water disposal at resettlement houses. The current CSCO visit (July 2023) however, established that although grass was planted in the compounds of the PAPs houses as per TEPU's commitment and response to CSCO's previous observation, the issue of the gutters which are not properly connected to any outfall drainage system still remain.</p> <p>It should be noted that failure to connect gutters to any outfall drainage system creates dampness in buildings and accelerates weakening of buildings through capillary attraction and seepage of uncontrolled storm water. The practice of leaving building gutters open is contrary to regulation</p> <p>3.3.6.1 of the National Building Control Regulations.</p>	<p>The main gutters are connected to the rainwater harvest tanks. This means that the larger amount of rainwater flows into the tanks for household use, which is 5,000 litres. The downpipes are installed past the concrete apron (veranda) that protects the foundations of the building. The hard base below the down pipe aids in flow of the water away from the splash apron. There is therefore little likelihood of storm water flowing into the foundations of the house and creating dampness or weakening the building.</p>

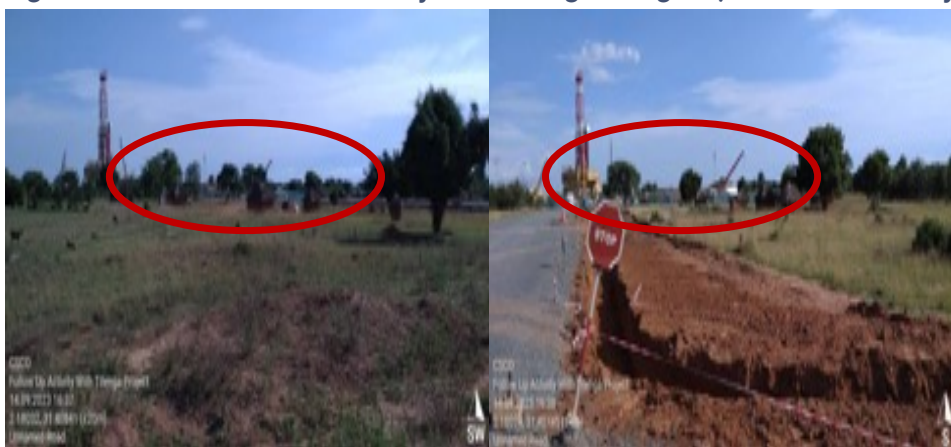
**Figure 13: Households located very close to Rig 2 in Ngiri 3, Buliisa community**

Interactions with selected community representatives (i.e. PAPs) living near Rig 2 in Ngiri 3, Kirama village, Kigwera Sub county in Buliisa District revealed that oil activities at rig 2 in Ngiri 3 have generated unbearable noise, vibrations, and light intrusion. This was further confirmed by the district technical leaders, who emphasized that the noise and vibrations from oil activities, especially at Ngiri 3, have affected domestic birds and the people living near the site (within a distance of 10-30 meters) (see Figure 11).

**Conflict resolution:** TEPU should consider alternative approaches to resolve the emerging conflict at the Rig 2 in Ngiri 3, Kirama village, Kigwera Sub county in Bulisa District. Such approaches should be participatory involving the key stakeholders (including the community, Local Government leaders & opinion leaders) for better understanding of the root causes of the conflict and then generate responsive resolution. The District Community Development Department will play an important role in the conflict resolution.

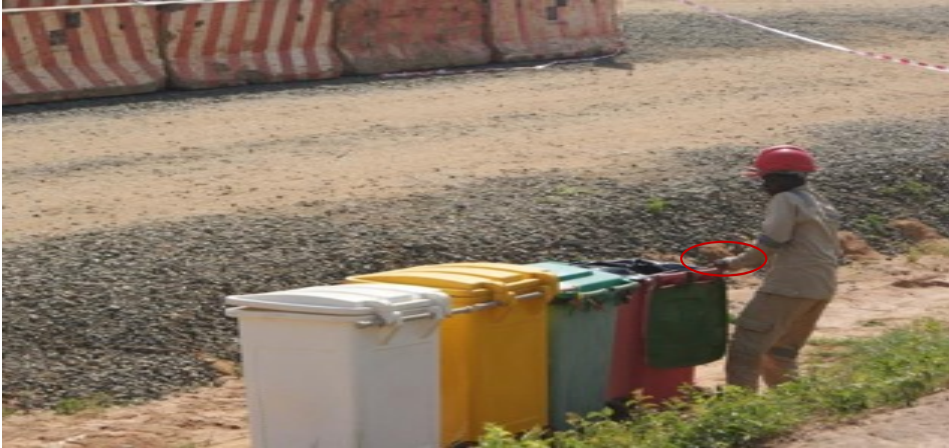
**Figure 14: A worker handling waste without gloves. Note that the red container is for hazardous waste at the entrance of the CFP in Buliisa**

It was observed that some workers, especially at the Central Processing Facility construction site, were handling hazardous waste with bare hands. Additionally, it was noted that the color-coded waste segregation bins at this site were not being used as prescribed. The team found mixed waste in some bins. At JBRI-5, the viewing point where visitors are addressed did not have any waste management containers. Furthermore, there was evidence of abandoned plastic waste at the Central Processing Facility in Bulisa.

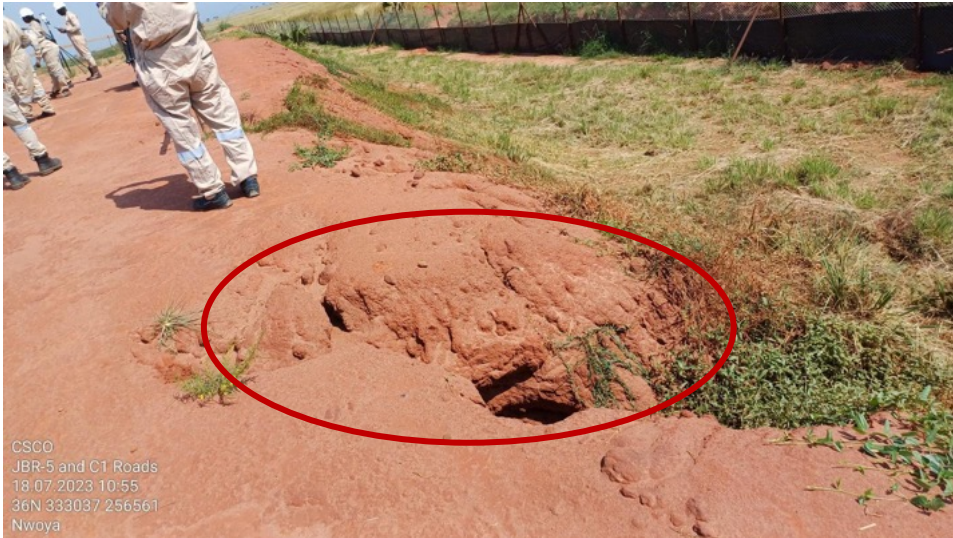
**Figure 16: Marks of erosion (Gullies) exhibiting signs of loss of aesthetics at the JBRI-5 well pad site.**

CSCO observed that drainage and erosion control remain a challenge, particularly at the Industrial Construction site and at JBRI-5 well pad construction area. Signs of erosion, including gullies, were evident at the viewpoint area (visitors' view ramp) at the JBRI-5. Additionally, water ponding was observed at various sections of the Industrial area.

It was observed that some of the areas within the Tilenga project, especially, around most of the construction sites and their surroundings have lost aesthetic beauty. This is due to the ongoing clearance and construction activities, which are associated with vegetation loss, dust emissions, water ponding, and surface run-offs. For example, the presence of gullies, water clogging, and dust emissions at both the industrial areas, and at the JBRI-5 well pad construction area have made these sites and their surroundings lose their aesthetic health and beauty (see Figure 14).

6.	<p><b>Inadequate drainage and erosion control systems</b></p> <p>CSCO observed that the issue of drainage and erosion control still remains a challenge, especially at the Industrial Construction site, and at JBRI-5 well pad construction area. Marks of erosion, notably gullies were present at the view point area (visitors' view ramp) at the JBRI-5. At the Industrial area, water ponding was evident at different sections of the site. Furthermore, at the industrial area, the following laxities on drainage system management were observed;</p> <p>i. Blocked and clogged drainage channels. Some drainage channels at the industrial area were silted and blocked with sediments. This indicates laxities in regular cleaning of the channels contrary to the requirements of the National Physical Planning Standards and Guidelines (2011)</p> <p>ii. There were no settling basins /containment basin for surface run-off at the facility. As such, it was established through debrief meetings with site representatives that surface run-off is released into the surrounding environment. This practice is contrary to the provisions of the Physical Planning standards and guidelines (2011) as well as the Public Health Act Cap 281 of the Laws of Uganda all of which discourage the direct release of surface run-off from facilities into surrounding environments.</p> <p>The National Physical Planning Act recommends the installation of settling basins at facilities and sites. The purpose is to ensure surface run-off from facilities gets collected in the settling basins where it can be managed through treatment before letting it out into the available public drainage channels, and NOT letting it out into the open environment</p>	<p>This has been well noted. The issue of stormwater management and siltation is currently being addressed as follows:</p> <ul style="list-style-type: none"> <li>- A full review of surface water drainage for the worksites has been completed.</li> <li>- The design of surface water management measures including attenuation basins, retention basins and silt traps is done on case-by-case basis.</li> <li>- A remedial action plan has been identified for each worksite with clear recommendations for improvement.</li> <li>- Remediation of areas at JRB5 well pad (including weekly emptying of silt traps, accelerated restoration of earth berms, installation of rip rap within drains, restoration of the area to south-west of JBR5 is currently being replanted, offshoots drainage to minimize single point loading and regular maintenance of the drainage system as a whole.</li> <li>- Regular monitoring of the performance of remedial measures is also being undertaken by way of daily inspections by field teams, weekly inspections by UWA and TEPU and regular aerial surveys to assess effectiveness of measures.</li> <li>- It is not possible to retain all surface water on our sites, therefore discharge to the surrounding environment is allowed for in the ESIA. The Company is committed to improving the current situation by ensuring appropriate design of settlement, treatment, and attenuation measures.</li> </ul>

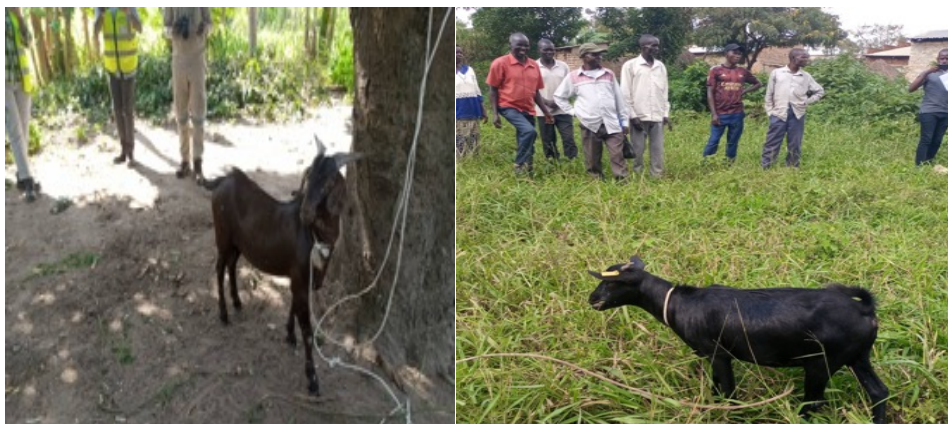
the PAPs were given improved goat breeds, they were not supported to construct appropriate goat housing/shelters that meet the minimum requirements for goat rearing, such as proper ventilating and aeration, among other necessary conditions. Unsurprisingly, the predominant issue reported by both the PAPs and district leaders during follow-up exercises was that of goats dying after receiving them as part of the livelihood improvement package. It should be noted that the best management practice for the distributed breed is construction of a goat shelter (to protect from wind, rain, and heat) and keeping the goats on a raised ground to control pest infestation, especially worms.

**Figure 17: Improved breeds of goats which were given to the PAPs In Buliisa.**

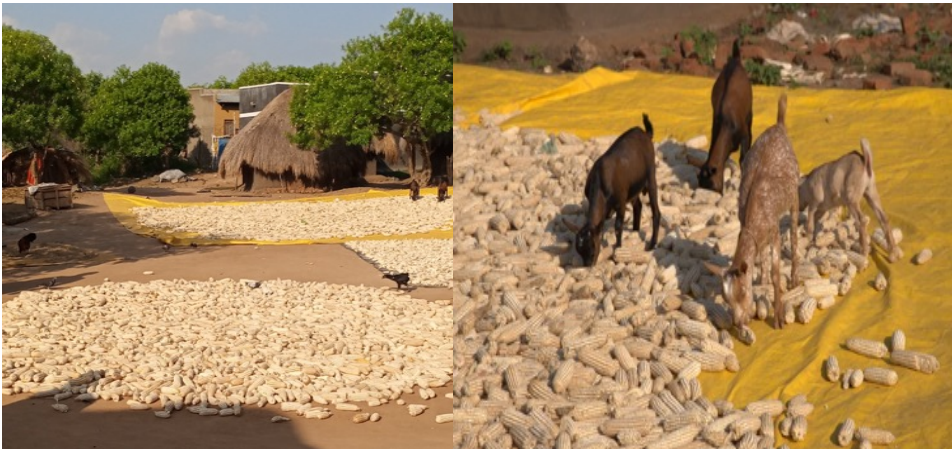
**Figure 19: Maize and cassava dried on the ground by one of the PAPs that operates the cassava chipper machine in Ngwedo, Buliisa district.**

While TEPU has implemented interventions to enhance value addition in selected crop value chains like cassava through provision of the cassava chipper under the livelihood restoration programme, the PAPs and the community visited during the monitoring exercise demonstrated inadequate post-harvest handling and management skills and knowledge. Despite showing proficiency in operating the cassava chipper, the monitoring team noted that the same PAP was still drying maize on bare ground. This indicates persistent knowledge gaps and barriers, such as limited skills, poor attitudes, and the inability to afford technology and equipment, among other limitations, especially concerning post-harvest handling of food.

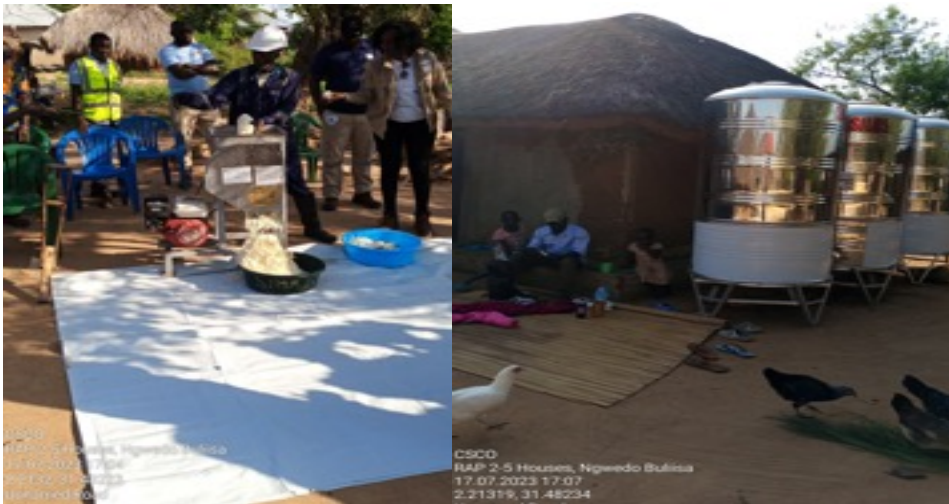
It is commendable that TEPU introduced new plant and animal varieties, (e.g. NAROCAS cassava variety, Karahari reds goats breed), practices, and equipment (such as cassava chipper and storage silos) as part of the interventions implemented for restoration of the livelihoods of the PAPs. However, these new technologies, practices, and equipment changes the previous way of livelihoods, culture, practices, values, and norms of the PAPs and project-affected community. The transition to apply and use these new technologies requires time, attitude, and mindset change for the PAPs and associated community. Without this in place, these technologies may not be easily adopted by PAPs, limiting the anticipated positive impacts on livelihoods improvement.

**Figure 20: Some of the technologies such as (left) cassava chipper for processing cassava, (right) cassava silos for storage of the processed cassava, introduced to the PAPs and project affected community**

While the cassava chipper may meet the technical fit requirements in terms of social and economic costs, there are concerns regarding its environmental impact requirements. It was noted that the cassava chipper runs on a diesel engine, which is associated with the release of greenhouse gases. Thus, alternative clean energy sources, such as solar power should be explored to operate the cassava chipper. Solar technology not only reduces environmental impact, but lowers maintenance costs as well. Additionally, the operation of the chipper machine generates dust, posing potential long-term health risk to the users. Therefore, users should receive awareness about these issues and be provided with appropriate protective gear.

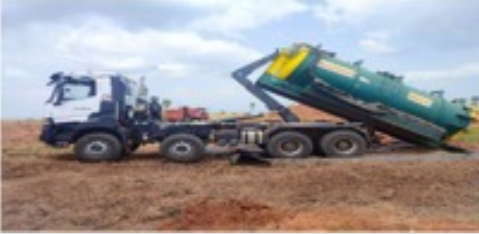
<p>Muds and cuttings from Construction sites come from Water Well Drilling and they are carried in sealed Vacuum trucks (as below) thus the event of spilling is untannable.</p>
